WADC TECHNICAL REPORT 52-226
PART 2

INVESTIGATION OF AXIAL LOADING FATIGUE
PROPERTIES OF HEAT RESISTANT ALLOY N-155

Part 2. An Exploratory Investigation of the Effect of Temperature,
Time, and Stress on Fracture Characteristics
and Metallographic Structure of N-155
and Hardness of N-155 and S-816

Fred W. DeMoney
University of Minnesota

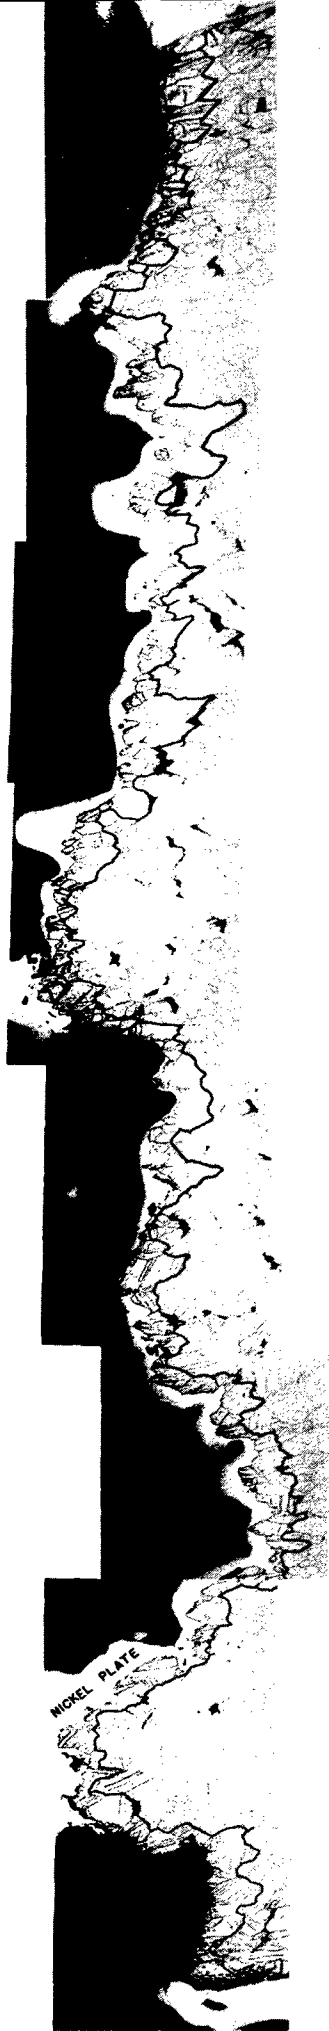
A. JB-5: STRESS RATIO A=0: MAX. STRESS $S_c=22.5$ KSI: HRS. TO FRACT.=20.7: INTERCRYST. FRACT.=96 %

B. JW-4: STRESS RATIO A=25: MAX. STRESS $S_c=30.0$ KSI: HRS. TO FRACT.=8.0: INTERCRYST. FRACT.=54 %

C. JV-13: STRESS RATIO A=67: MAX. STRESS $S_c=37.0$ KSI: HRS. TO FRACT.=10.9: INTERCRYST. FRACT.=41 %

FIG.2 FRACTURE-PROFILES OF SPECIMENS TESTED AT 1500°F. ORIGINAL MAG. 150 X

A representative series of fracture-profiles are shown in Figures 2 and 3. The results obtained from this analysis are shown in Table I and are plotted in Figure 4. Data obtained from a previous investigation (1) are also shown. It is seen that the four test variables--time, temperature, stress, and stress ratio--influence the type of fracture and these effects will be discussed in the following sections.
